Flood Control Project Maintenance**2012 Structure Summary Report****Overall Unit and Item Ratings****DWR Sutter Maintenance Yard****Butte Slough Drainage Structure**

Flood Control Project Maintenance
2012 Structure Summary Report
Overall Unit and Item Ratings

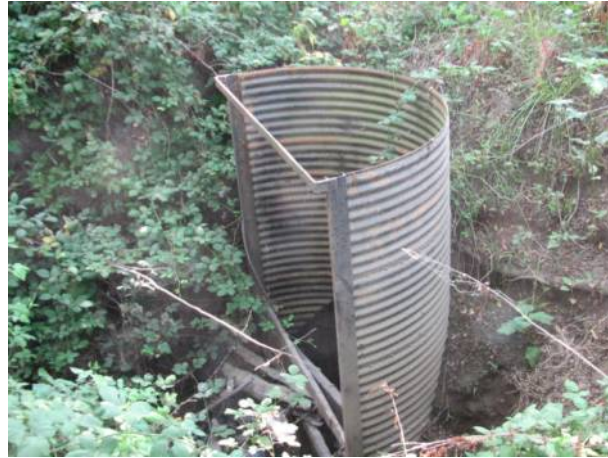
Levee Mile Report Line	1
Start Levee Mile	0.00
End Levee Mile	0.00
Location	
Category	Structures
Item	Photo Documentation
08/04/2011 Butte Slough Drainage structure on the land side.	
mkhashch_t_20120709_016.jpg

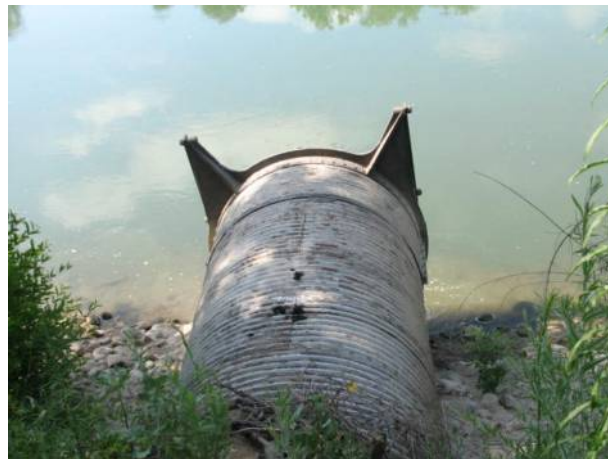
Levee Mile Report Line	1
Start Levee Mile	0.00
End Levee Mile	0.00
Location	
Category	Structures
Item	Photo Documentation
08/04/2011 Butte Slough Drainage structure outfall.	
mkhashch_t_20120709_017.jpg

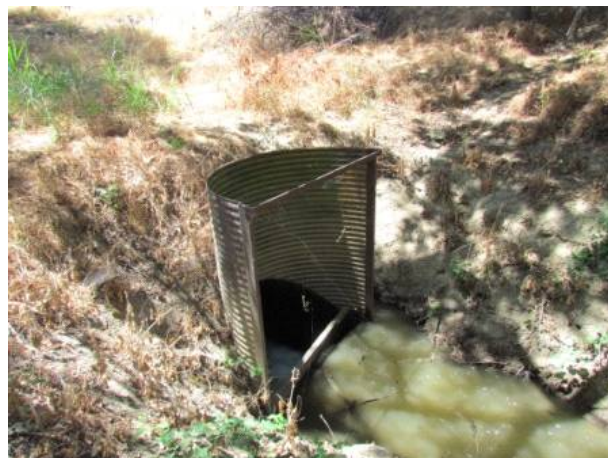
Levee Mile Report Line	1
Start Levee Mile	0.00
End Levee Mile	0.00
Location	
Category	Structures
Item	Photo Documentation
07/30/2012 Butte Slough Drainage structure on the land side.	
mkhashch_t_20120801_514.JPG

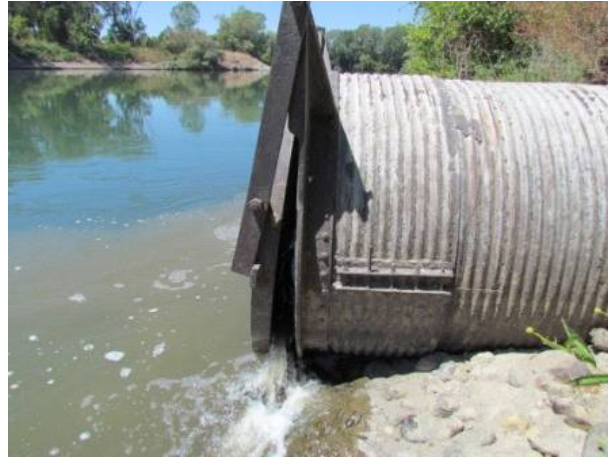
Levee Mile Report Line	1
Start Levee Mile	0.00
End Levee Mile	0.00
Location	
Category	Structures
Item	Photo Documentation
07/30/2012 Butte Slough Drainage structure outfall.	
mkhashch_t_20120801_515.JPG

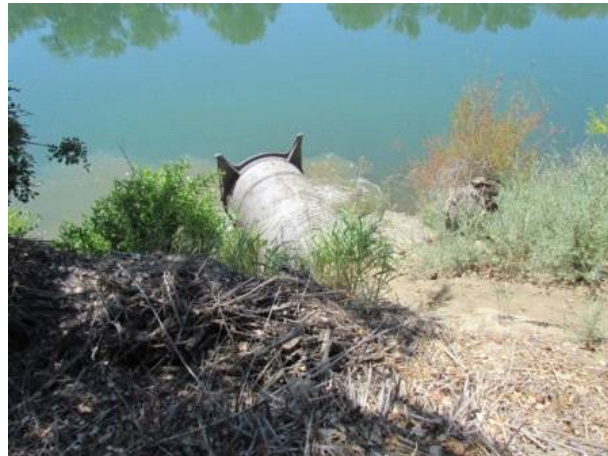
Levee Mile Report Line	1
Start Levee Mile	0.00
End Levee Mile	0.00
Location	
Category	Structures
Item	Photo Documentation
07/30/2012 Butte Slough Drainage structure outfall.	
mkhashch_t_20120801_516.JPG

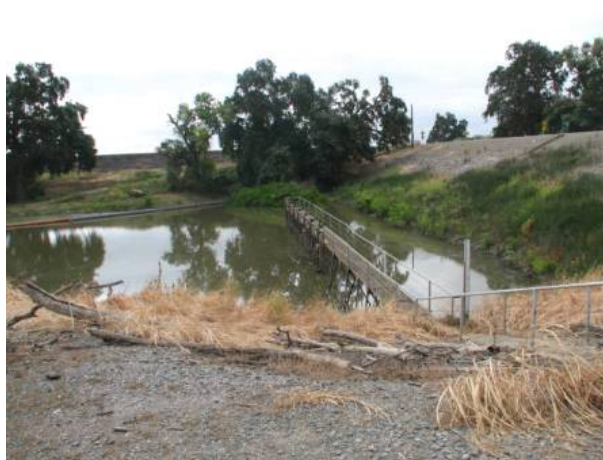
Levee Mile Report Line	1
Start Levee Mile	0.00
End Levee Mile	0.00
Location	
Category	Structures
Item	Photo Documentation
08/04/2011 View of the Butte Slough Outfall Structure on the land side.	
mkhashch_t_20120709_018.jpg

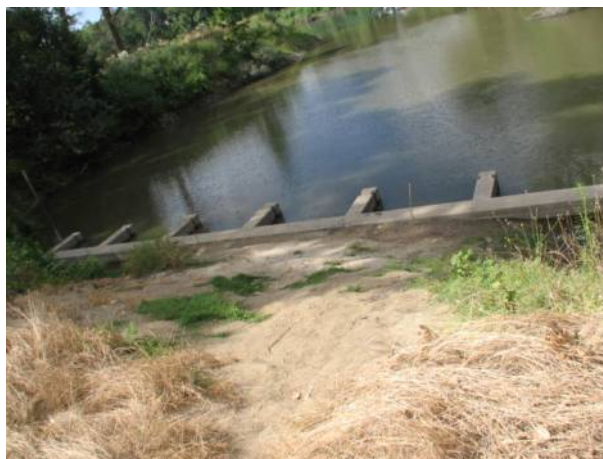
Levee Mile Report Line	1
Start Levee Mile	0.00
End Levee Mile	0.00
Location	
Category	Structures
Item	Photo Documentation
08/04/2011 View of the Butte Slough Outfall Structure on the water side.	
mkhashch_t_20120709_019.jpg

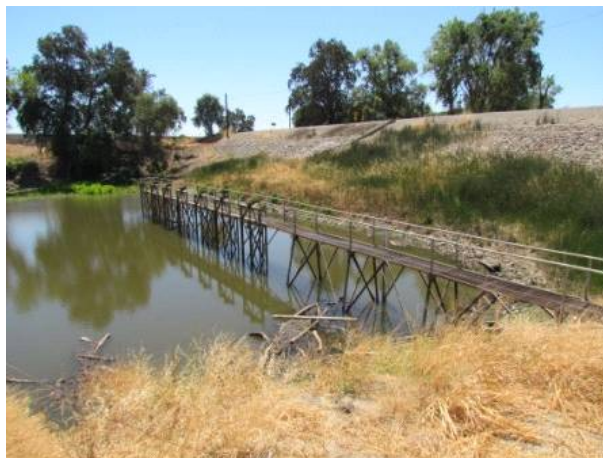
Levee Mile Report Line	1
Start Levee Mile	0.00
End Levee Mile	0.00
Location	
Category	Structures
Item	Photo Documentation
07/30/2012 View of the Butte Slough Outfall Structure on the land side.	
mkhashch_t_20120801_517.JPG

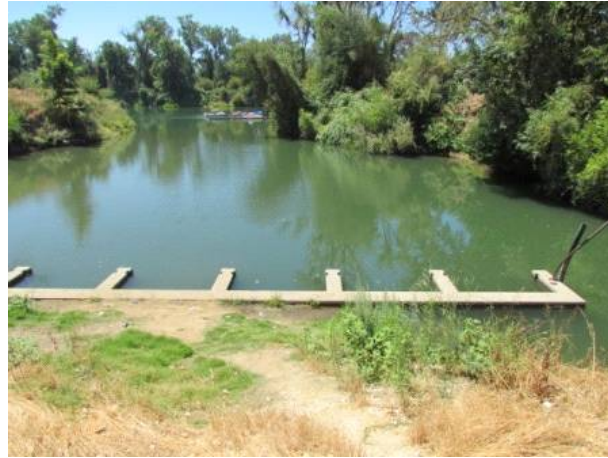
Levee Mile Report Line	1
Start Levee Mile	0.00
End Levee Mile	0.00
Location	
Category	Structures
Item	Photo Documentation
07/30/2012 View of the Butte Slough Outfall Structure on the water side.	
mkhashch_t_20120801_518.JPG

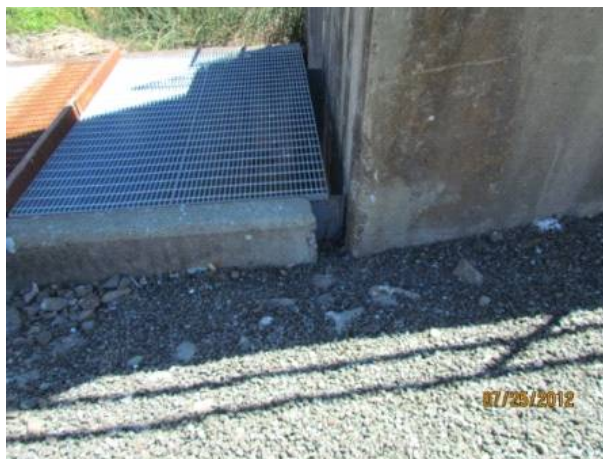
pkazi_t_20120810_174.jpg

View of the settlement next to the pumping plant.

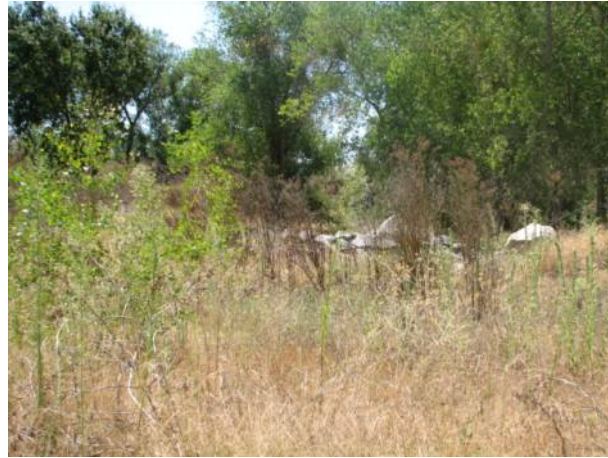
cathom_t_20120827_057.JPG

This is a view of the vegetation in front of the weir.

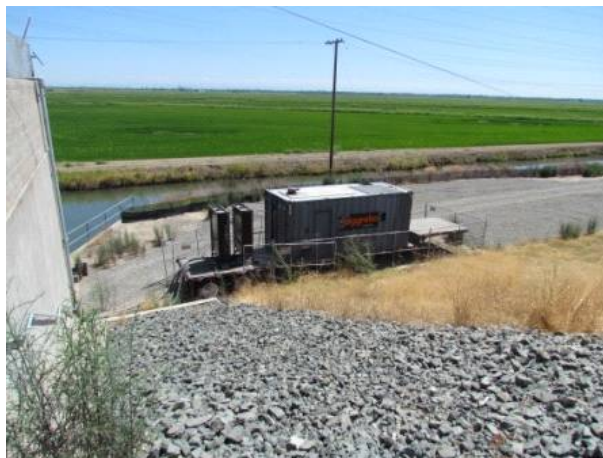
Levee Mile Report Line	8
Start Levee Mile	0.00
End Levee Mile	0.00
Location	
Category	Pump Stations
Item	Power
07/20/2012 Photo shows emergency generator that is being kept on site to operate the pumps, if necessary during reconstruction.	
mkhashch_t_20120723_486.JPG

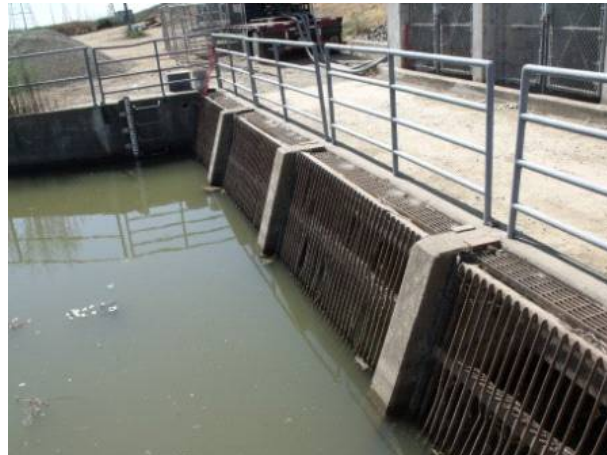
Levee Mile Report Line	12
Start Levee Mile	0.00
End Levee Mile	0.00
Location	
Category	Pump Stations
Item	Trash Racks
08/24/2011 Photo shows properly maintained trash rack.	
mkhashch_t_20120709_022.jpg

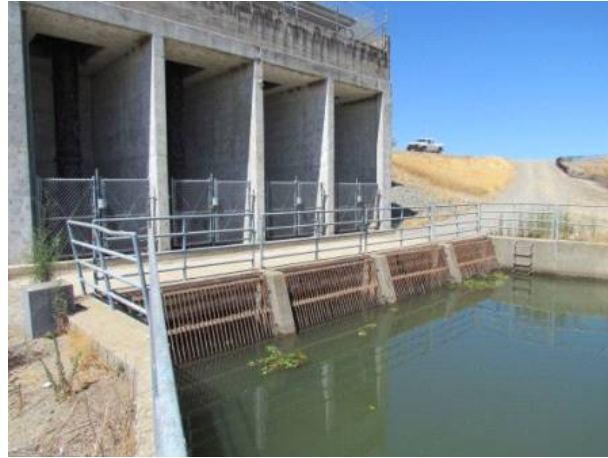
Levee Mile Report Line	12
Start Levee Mile	0.00
End Levee Mile	0.00
Location	
Category	Pump Stations
Item	Trash Racks
07/20/2012 Photo shows properly maintained trash rack.	
mkhashch_t_20120723_488.JPG

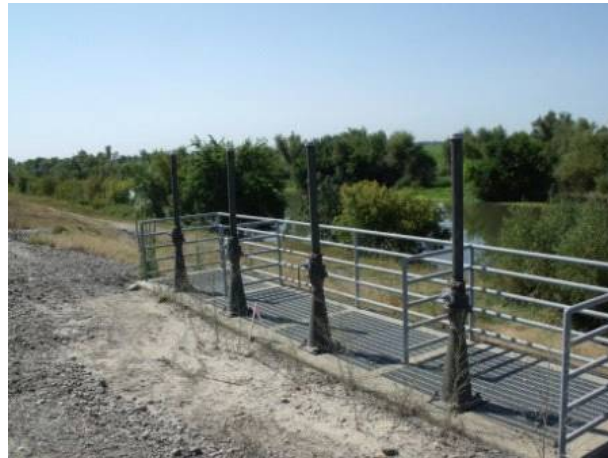
Levee Mile Report Line	16
Start Levee Mile	0.00
End Levee Mile	0.00
Location	
Category	Pump Stations
Item	Manual Gate Operators
08/24/2011 Photo shows sluice gate operators. Note: operators can be operated either mechanically or manually.	
mkhashch_t_20120709_023.jpg

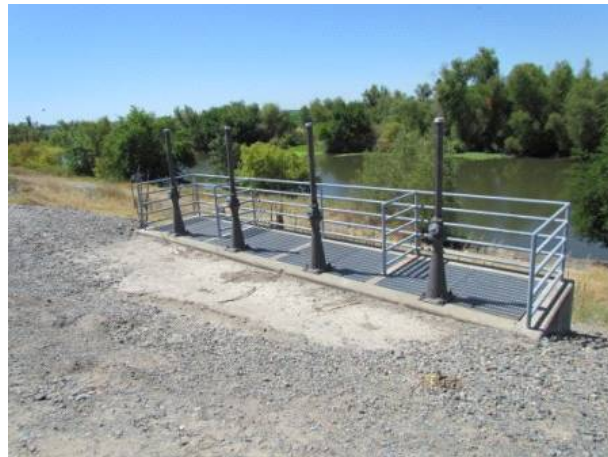
Levee Mile Report Line	16
Start Levee Mile	0.00
End Levee Mile	0.00
Location	
Category	Pump Stations
Item	Manual Gate Operators
07/20/2012 Photo shows sluice gate operators. Note: operators can be operated either mechanically or manually.	
mkhashch_t_20120723_489.JPG

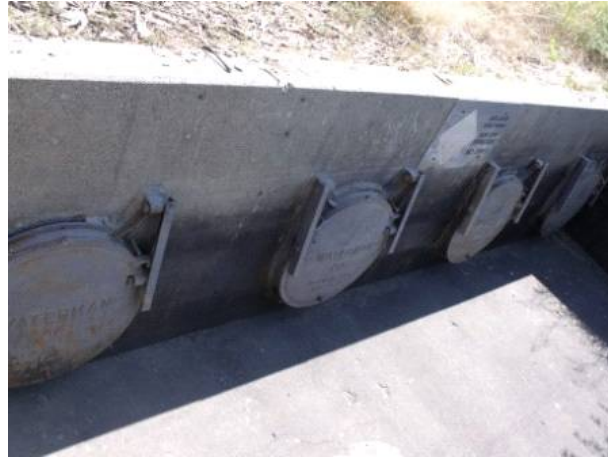
Levee Mile Report Line	18
Start Levee Mile	0.00
End Levee Mile	0.00
Location	
Category	Pump Stations
Item	Flap Gates
08/24/2011 Photo shows flap gates and concrete outfall structure.	
mkhashch_t_20120709_024.jpg

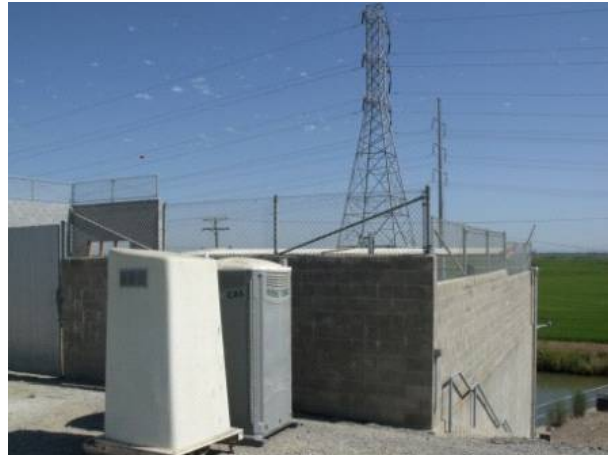
Levee Mile Report Line	20
Start Levee Mile	0.00
End Levee Mile	0.00
Location	
Category	Pump Stations
Item	Security Fencing
08/24/2011 Photo shows masonry brick wall which encloses the pump plant.	
mkhashch_t_20120709_025.jpg

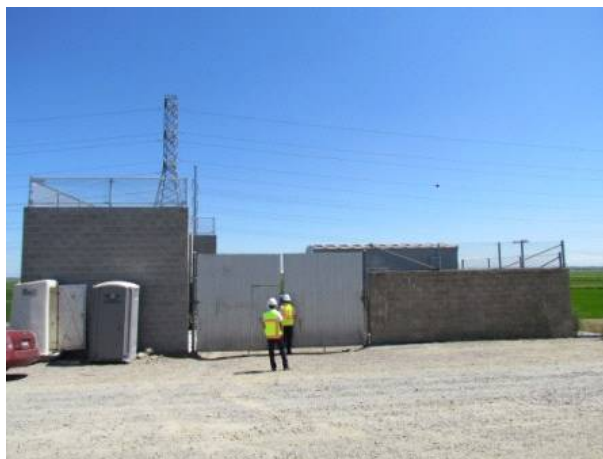
Levee Mile Report Line	20
Start Levee Mile	0.00
End Levee Mile	0.00
Location	
Category	Pump Stations
Item	Security Fencing
07/20/2012 Photo shows masonry brick wall which encloses the pump plant.	
mkhashch_t_20120723_491.JPG

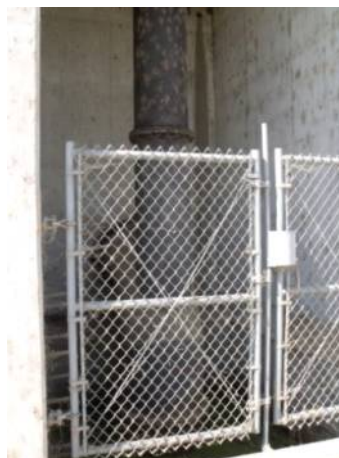
Levee Mile Report Line	21
Start Levee Mile	0.00
End Levee Mile	0.00
Location	
Category	Pump Stations
Item	Intake and Discharge Pipes
08/24/2011 Photo shows pump intake pipe, typical.	
mkhashch_t_20120709_026.jpg

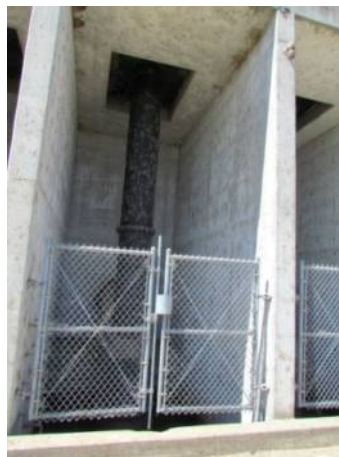
Levee Mile Report Line	21
Start Levee Mile	0.00
End Levee Mile	0.00
Location	
Category	Pump Stations
Item	Intake and Discharge Pipes
07/20/2012 Photo shows pump intake pipe, typical.	
mkhashch_t_20120723_492.JPG

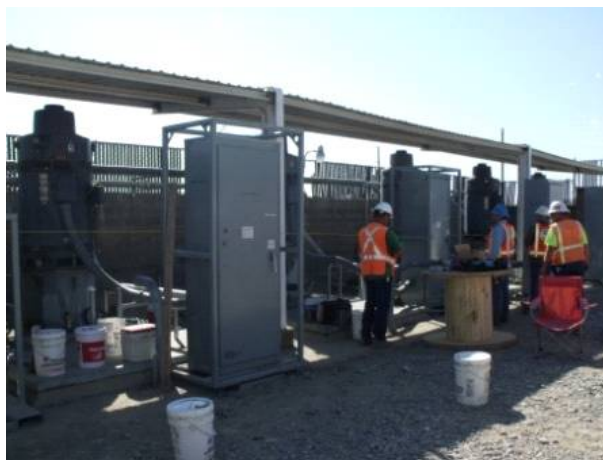
Levee Mile Report Line	7
Start Levee Mile	0.00
End Levee Mile	0.00
Location	
Category	Pump Stations
Item	Pumps
08/24/2011 Photo shows preparation of pumps for testing.	
mkhashch_t_20120709_027.jpg

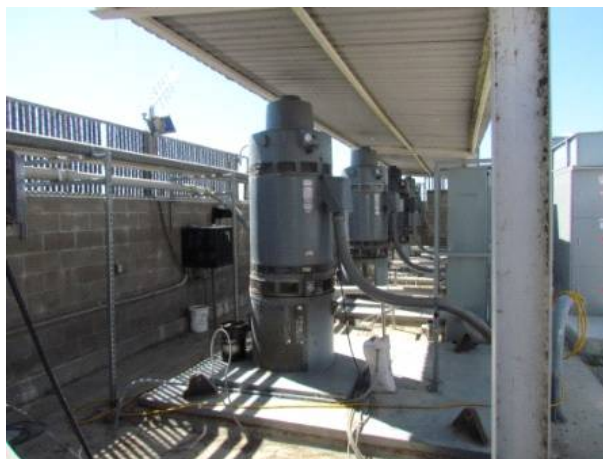
Levee Mile Report Line	7
Start Levee Mile	0.00
End Levee Mile	0.00
Location	
Category	Pump Stations
Item	Pumps
07/20/2012 Photo shows pumps connected to temporary power supply during construction.	
mkhashch_t_20120723_478.JPG

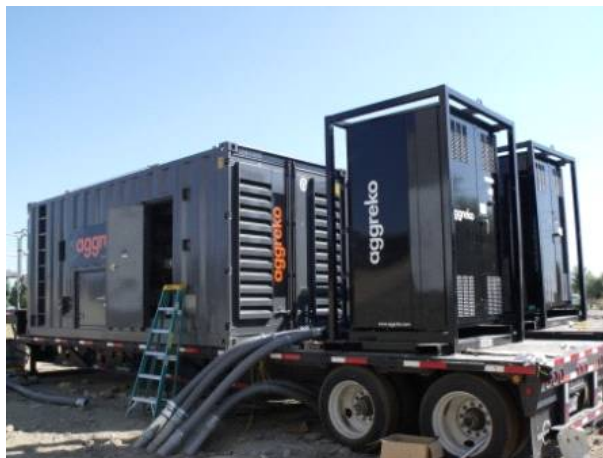
Levee Mile Report Line	8
Start Levee Mile	0.00
End Levee Mile	0.00
Location	
Category	Pump Stations
Item	Power
08/24/2011 Photo shows two generators which are being kept on site for emergency operation of the pumps.	
mkhashch_t_20120709_028.jpg

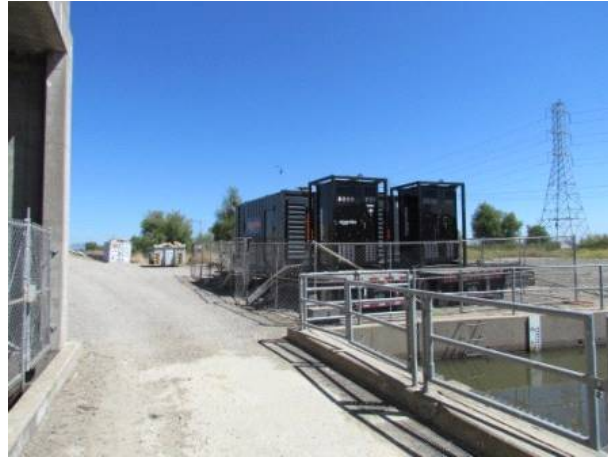
mkhashch_t_20120723_479.JPG

07/20/2012 Photo shows two generators which are being kept on site for emergency operation of the pumps.

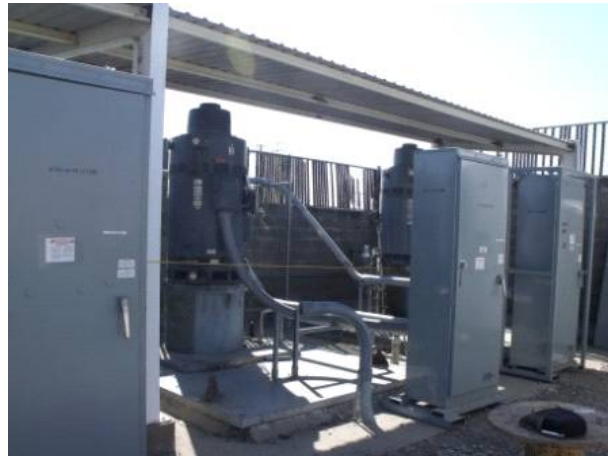
mkhashch_t_20120709_029.jpg

08/24/2011 Photo shows motors in place at site.

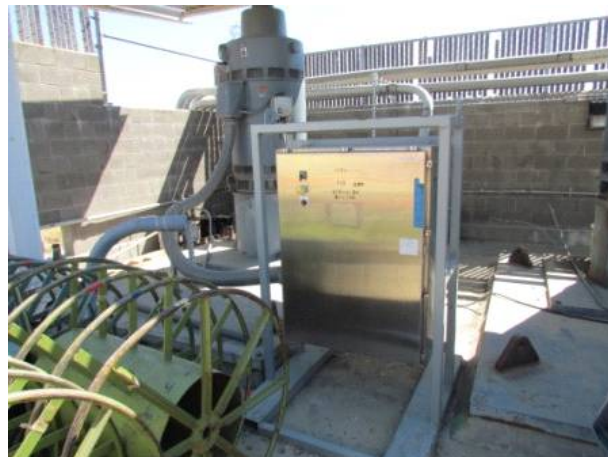
mkhashch_t_20120723_480.JPG

07/20/2012 Photo shows motors in place at site.

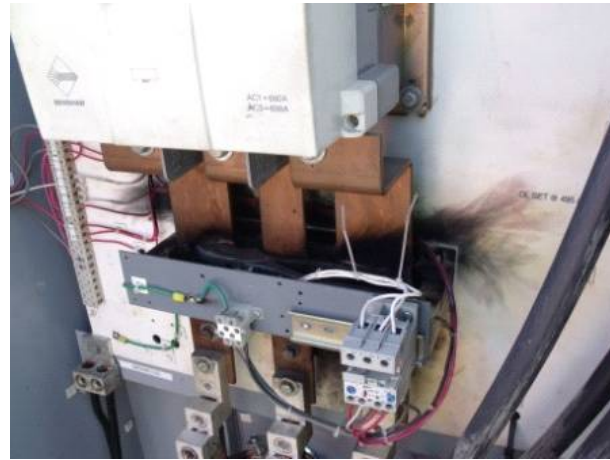
Levee Mile Report Line	10
Start Levee Mile	0.00
End Levee Mile	0.00
Location	
Category	Pump Stations
Item	Pump Control Systems
08/24/2011 Photo shows pump control system unit damaged during testing. Note pliers in photo, which may have caused short circuit.	
mkhashch_t_20120709_030.jpg

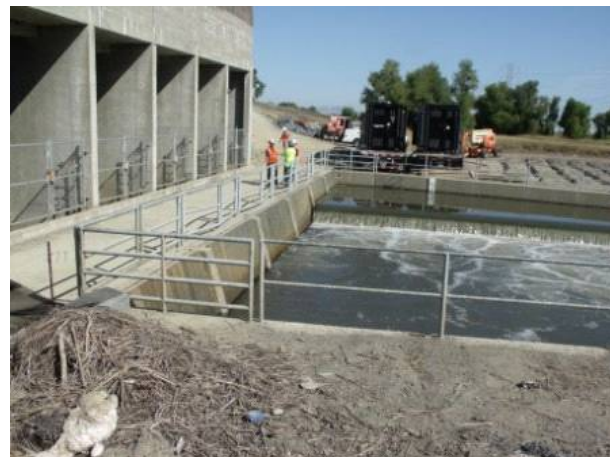
Levee Mile Report Line	12
Start Levee Mile	0.00
End Levee Mile	0.00
Location	
Category	Pump Stations
Item	Trash Racks
08/24/2011 Photo shows row of trash racks (six).	
mkhashch_t_20120709_032.jpg

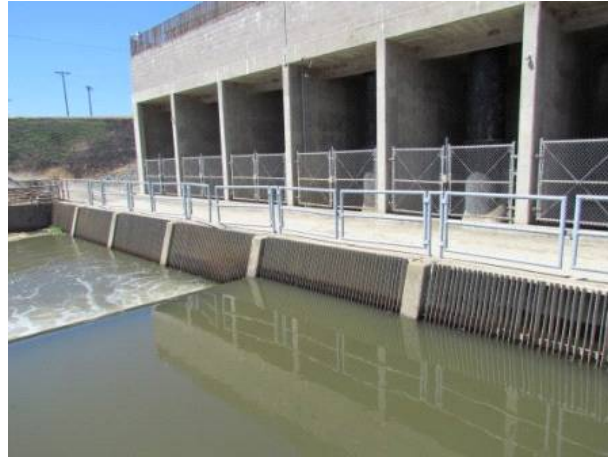
Levee Mile Report Line	12
Start Levee Mile	0.00
End Levee Mile	0.00
Location	
Category	Pump Stations
Item	Trash Racks
07/20/2012 Photo shows row of trash racks (six).	
mkhashch_t_20120723_482.JPG

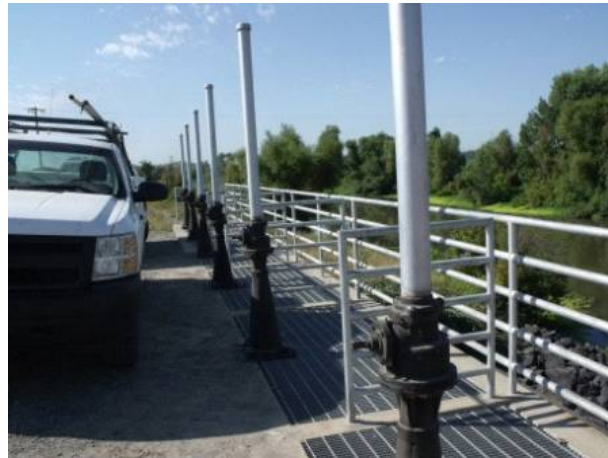
Levee Mile Report Line	16
Start Levee Mile	0.00
End Levee Mile	0.00
Location	
Category	Pump Stations
Item	Manual Gate Operators
08/24/2011 Photo shows controls for sluice gates.	
mkhashch_t_20120709_033.jpg

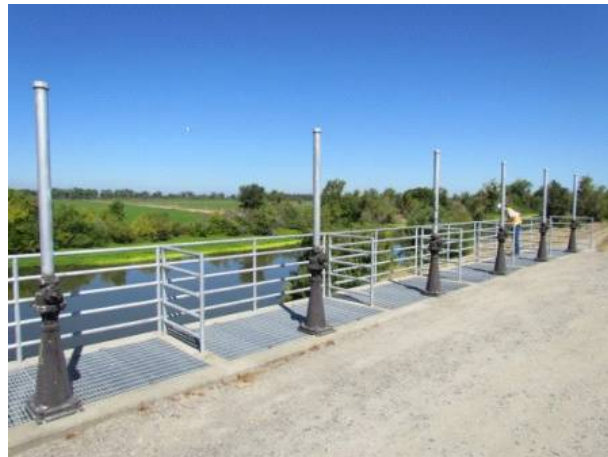
Levee Mile Report Line	16
Start Levee Mile	0.00
End Levee Mile	0.00
Location	
Category	Pump Stations
Item	Manual Gate Operators
07/20/2012 Photo shows controls for sluice gates.	
mkhashch_t_20120723_483.JPG

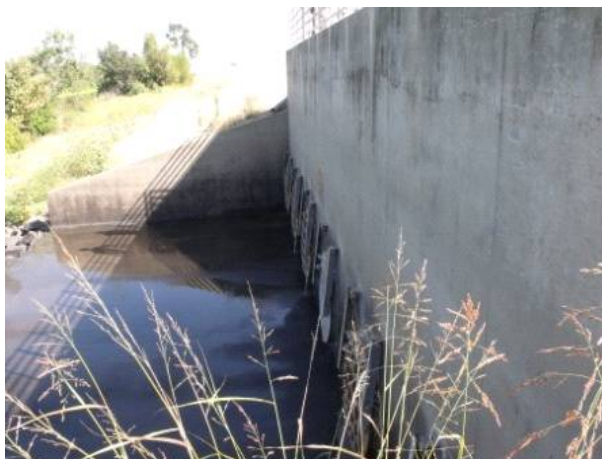
mkhashch_t_20120709_034.jpg

08/24/2011 Photo shows flap gates. Note water is the result of the motor/pump testing.

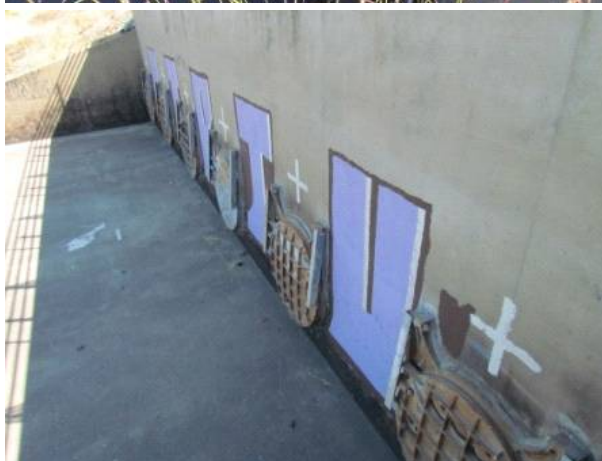
mkhashch_t_20120723_484.JPG

07/20/2012 View of flap gates.

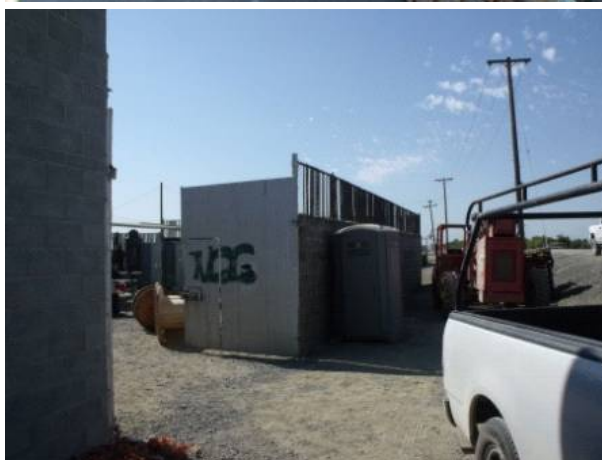
mkhashch_t_20120709_035.jpg

08/24/2011 Photo shows masonry block wall which encloses the site.

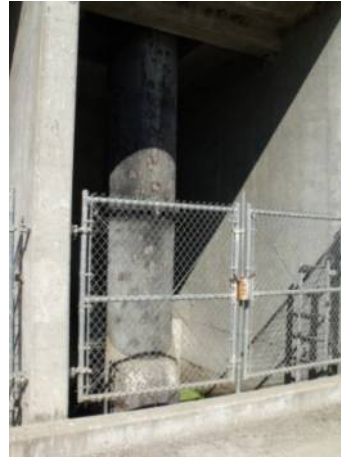
Levee Mile Report Line	21
Start Levee Mile	0.00
End Levee Mile	0.00
Location	
Category	Pump Stations
Item	Intake and Discharge Pipes
08/24/2011 Photo shows intake pipe, typical.	
mkhashch_t_20120709_036.jpg

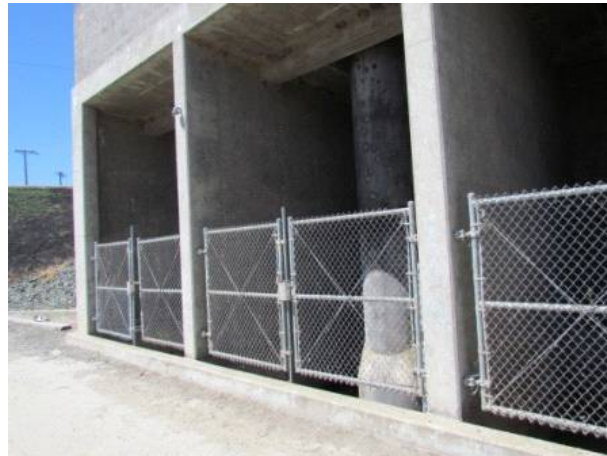
Levee Mile Report Line	21
Start Levee Mile	0.00
End Levee Mile	0.00
Location	
Category	Pump Stations
Item	Intake and Discharge Pipes
07/20/2012 View of intake structure, typical.	
mkhashch_t_20120723_485.JPG

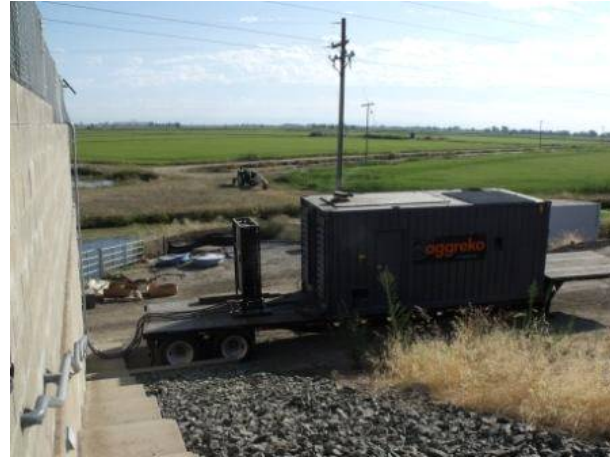
mkhashch_t_20120709_037.jpg

08/24/2011 Photo shows portable generator which is to remain on site until the construction is completed.

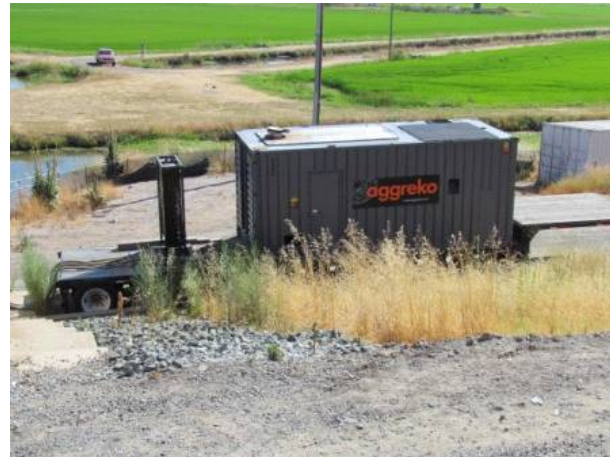
mkhashch_t_20120723_470.JPG

07/20/2012 Photo shows portable generator which is to remain on site until the construction is completed.

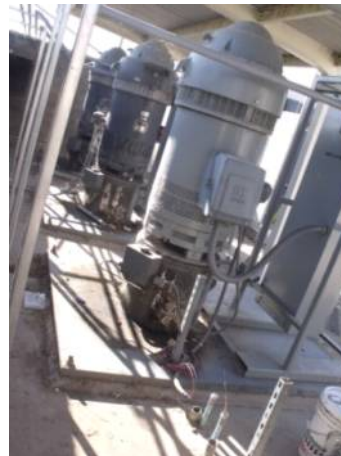
mkhashch_t_20120709_038.jpg

08/24/2011 Photo shows motors which appear to be maintained and in good working condition.

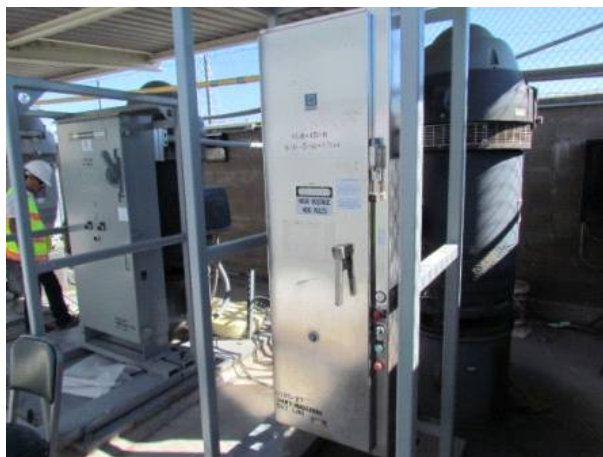
Levee Mile Report Line	9
Start Levee Mile	0.00
End Levee Mile	0.00
Location	
Category	Pump Stations
Item	Motors, Engines, Fans & Gear Reducers
07/20/2012 Photo shows motors in the background which appear to be maintained and in good working condition.	
mkhashch_t_20120723_471.JPG

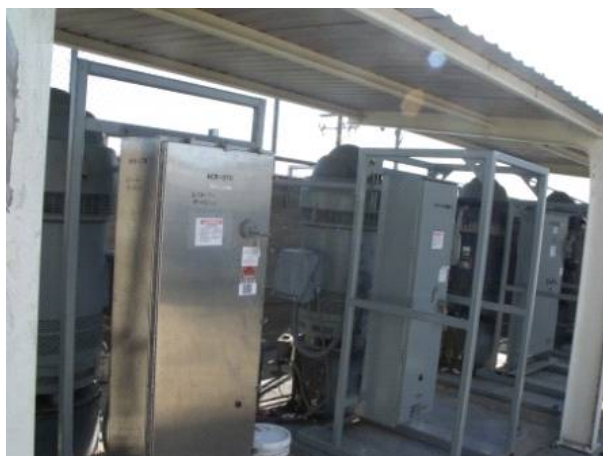
Levee Mile Report Line	10
Start Levee Mile	0.00
End Levee Mile	0.00
Location	
Category	Pump Stations
Item	Pump Control Systems
08/24/2011 Photo shows new control panels, which are being installed as part of the new construction.	
mkhashch_t_20120709_039.jpg

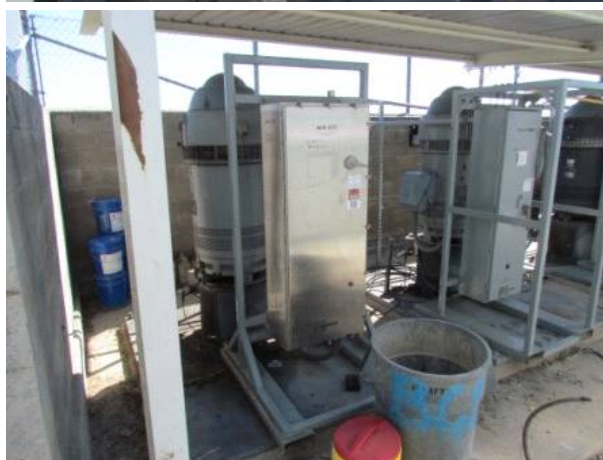
Levee Mile Report Line	10
Start Levee Mile	0.00
End Levee Mile	0.00
Location	
Category	Pump Stations
Item	Pump Control Systems
07/20/2012 Photo shows temporary control panels. Permanent controls will be located in the new pump building.	
mkhashch_t_20120723_472.JPG

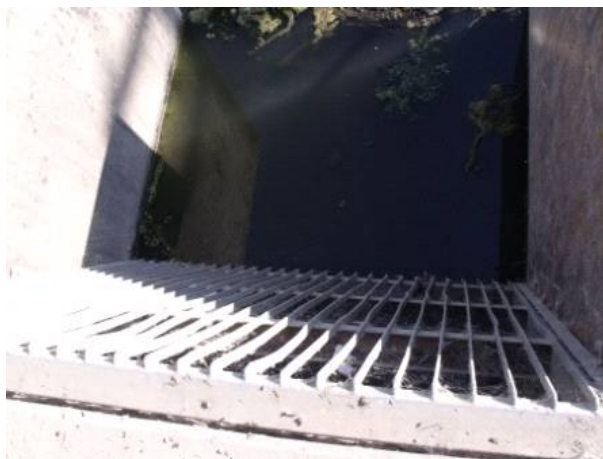
mkhashch_t_20120709_040.jpg

08/24/2011 Photo shows trash rack free of debris and other material.

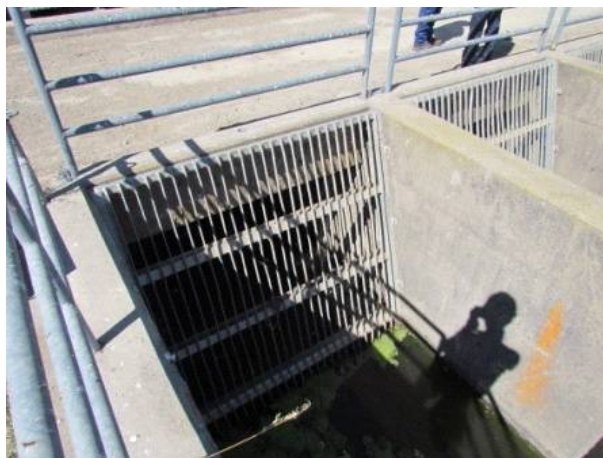
mkhashch_t_20120723_473.JPG

07/20/2012 Photo shows trash rack free of debris and other material.

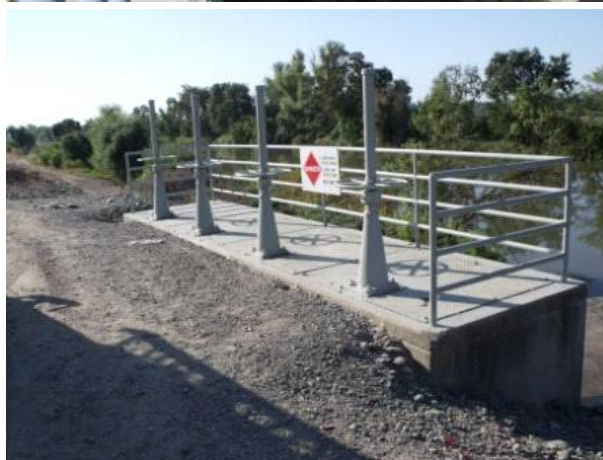
mkhashch_t_20120709_041.jpg

08/24/2011 Photo shows manual gate operators.

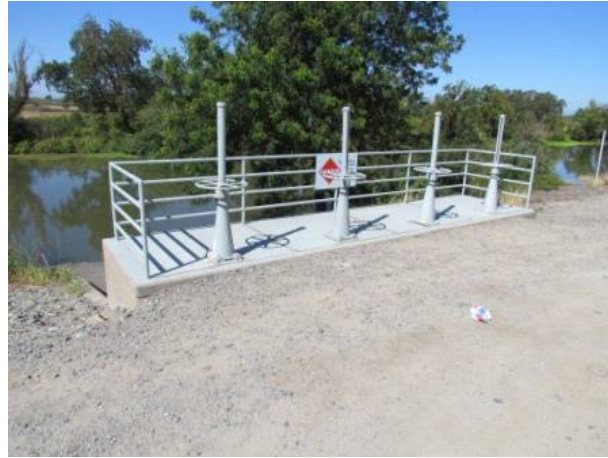
mkhashch_t_20120723_474.JPG

07/20/2012 Photo shows manual gate operators.

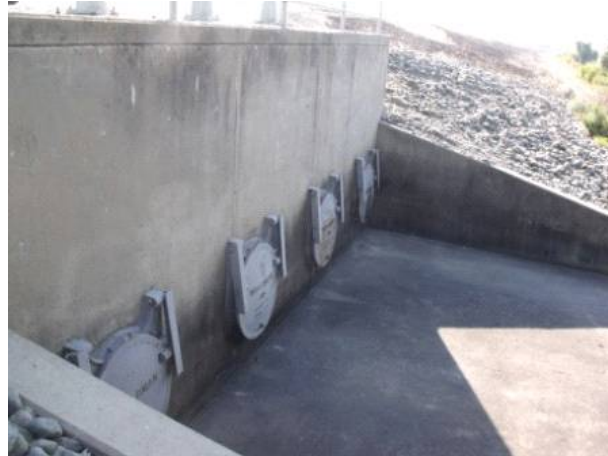
mkhashch_t_20120709_042.jpg

08/24/2011 Photo shows flap gates and concrete outfall structure.

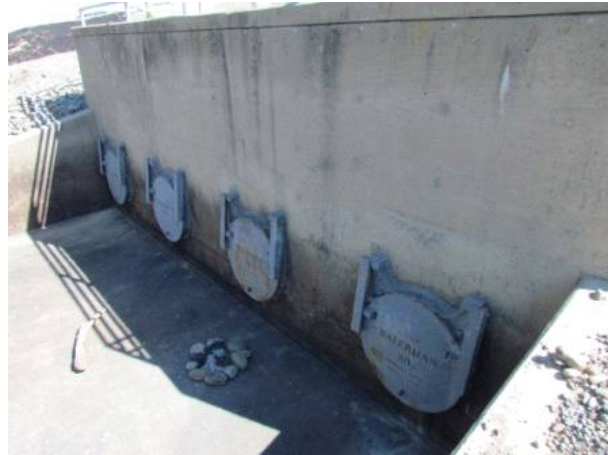
mkhashch_t_20120723_475.JPG

07/20/2012 Photo shows flap gates and concrete outfall structure.

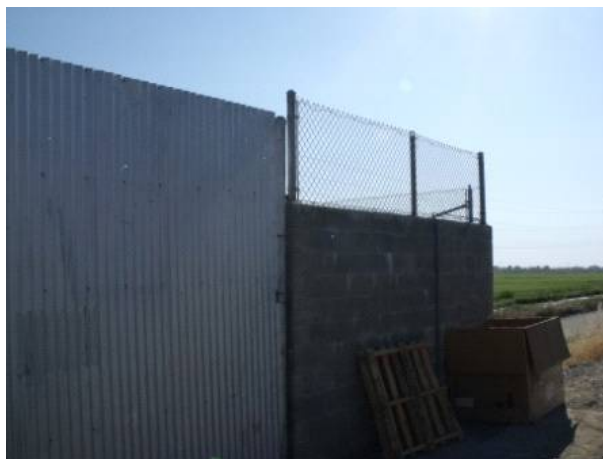
Levee Mile Report Line	20
Start Levee Mile	0.00
End Levee Mile	0.00
Location	
Category	Pump Stations
Item	Security Fencing
08/24/2011 Photo shows masonry brick wall which encloses the entire structure.	
mkhashch_t_20120709_043.jpg

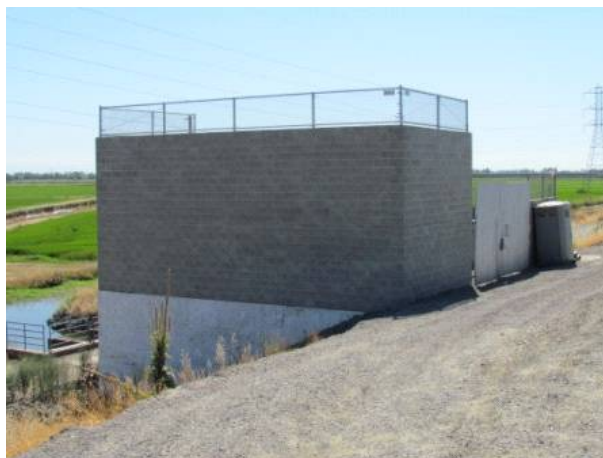
Levee Mile Report Line	20
Start Levee Mile	0.00
End Levee Mile	0.00
Location	
Category	Pump Stations
Item	Security Fencing
07/20/2012 Photo shows masonry brick wall which encloses the entire structure.	
mkhashch_t_20120723_476.JPG

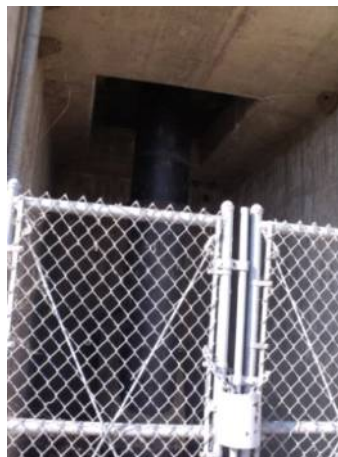
Levee Mile Report Line	21
Start Levee Mile	0.00
End Levee Mile	0.00
Location	
Category	Pump Stations
Item	Intake and Discharge Pipes
08/24/2011 Photo shows Intake pipe, typical.	
mkhashch_t_20120709_044.jpg

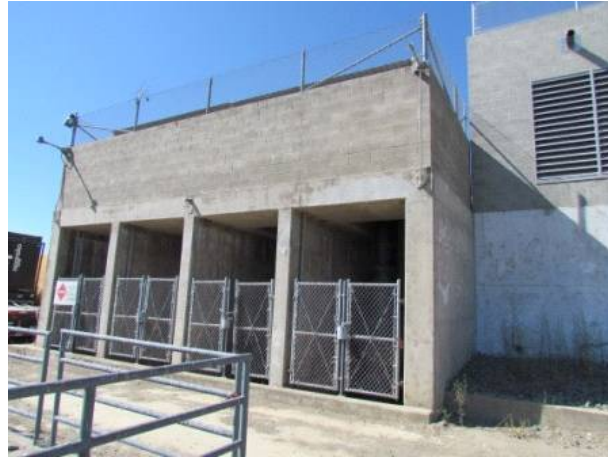
Levee Mile Report Line	21
Start Levee Mile	0.00
End Levee Mile	0.00
Location	
Category	Pump Stations
Item	Intake and Discharge Pipes
07/20/2012 Photo shows Intake structure.	
mkhashch_t_20120723_477.JPG

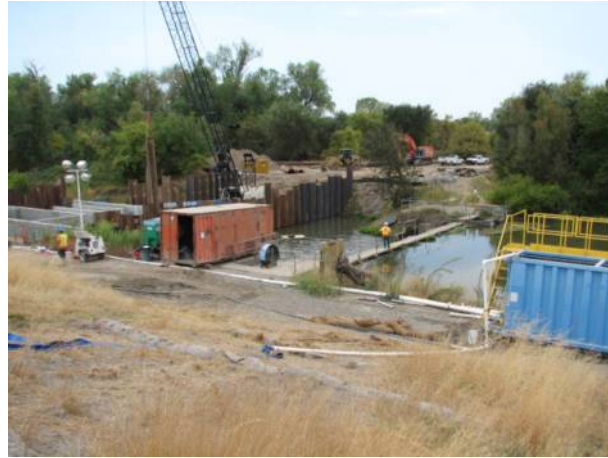
cathom_t_20120822_050.JPG

This is a view of the upstream side of the Sutter Bypass Weir No. 2.

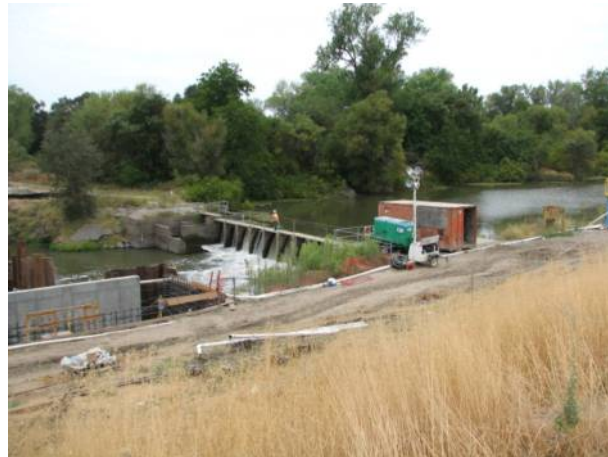
cathom_t_20120822_051.JPG

This is a view of the downstream side of the Sutter Bypass Weir No. 2. New construction of the replacement for weir no. 2 has already started.

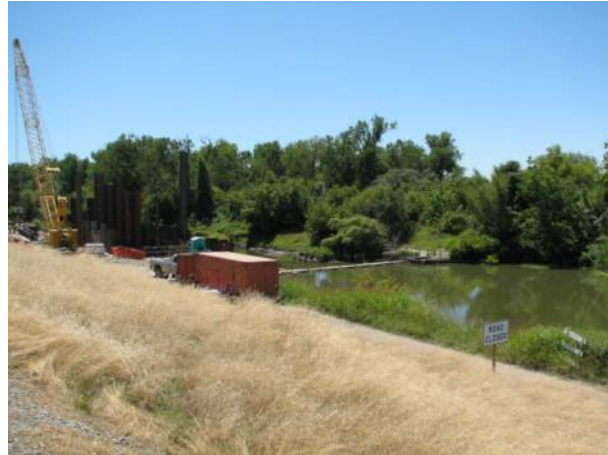
cathom_t_20120611_025.jpg

This is a view of the upstream side of the weir.

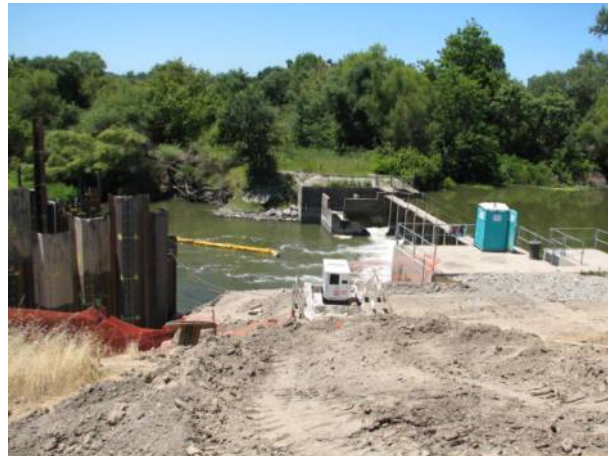
cathom_t_20120611_026.jpg

This is a view of the downstream side of the weir.

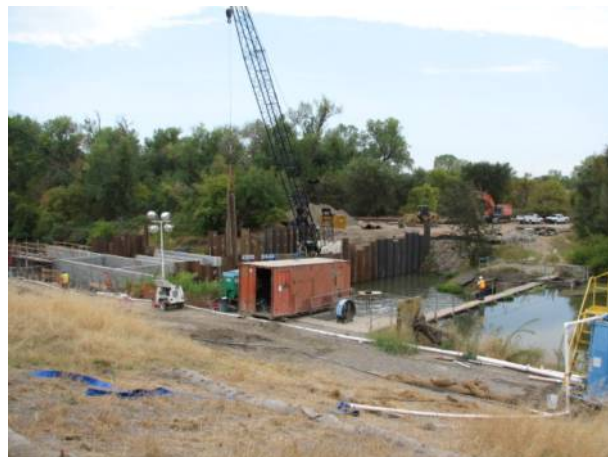
cathom_t_20120822_053.JPG

The replacement weir.

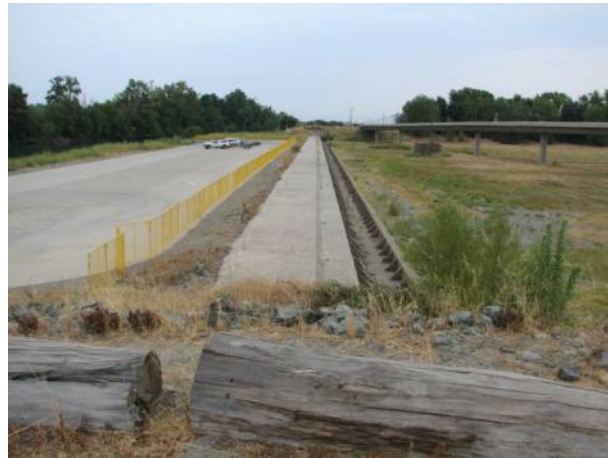
cathom_t_20120822_048.JPG

This view is of the Tisdale Weir from the right bank levee.

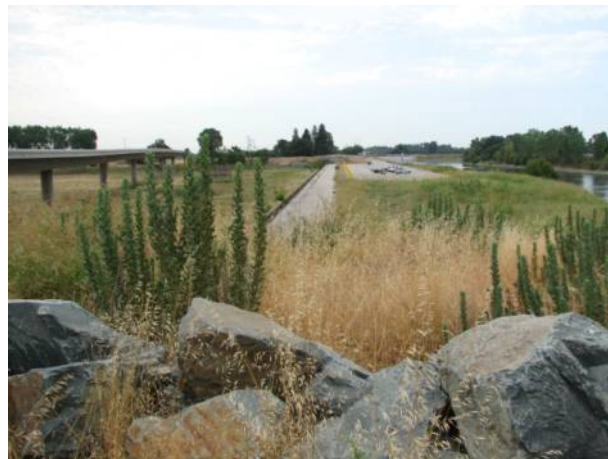
cathom_t_20120822_049.JPG

This view of the Tisdale Weir is from the left bank levee.

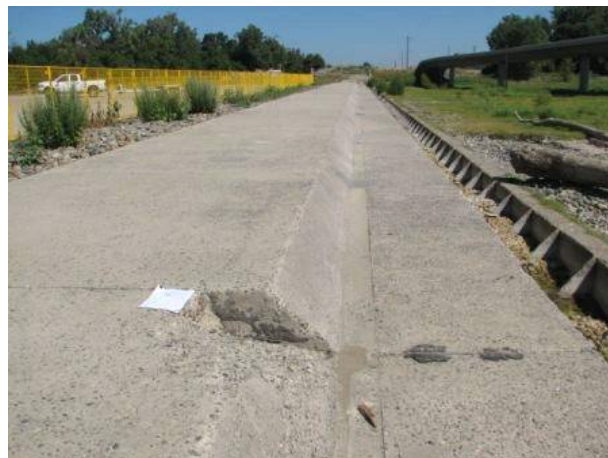
cathom_t_20120611_031.jpg

This photo shows some surface damage.

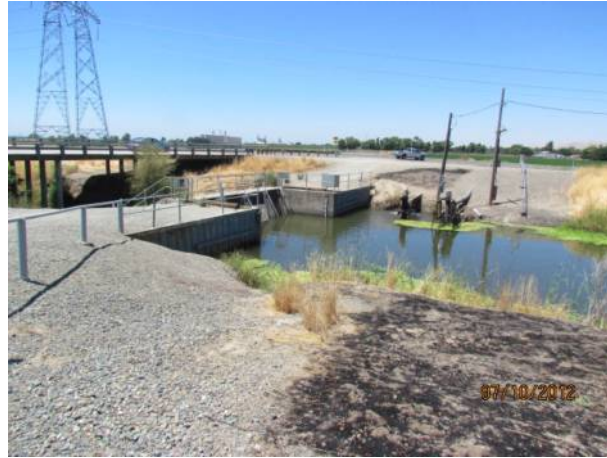
rduffey_t_20120710_017.jpg

View of the upstream side of the Wadsworth Canal Weir No. 4.

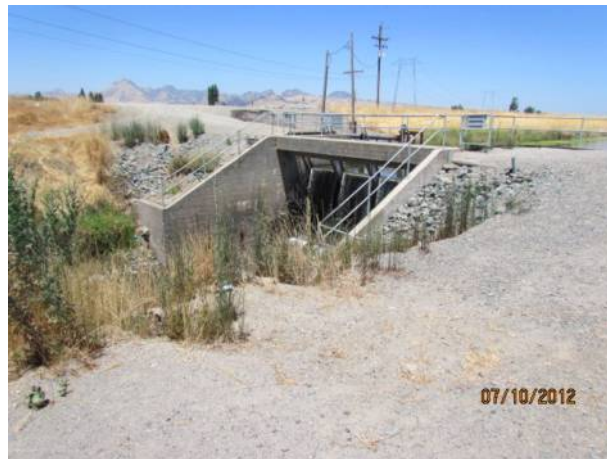
rduffey_t_20120710_016.jpg

View of the downstream side of the wadsworth canal weir No. 4 erosion along channel.
